Sidewall overcoat extends float furnace campaign

This article describes a project to apply a sidewall overcoat to the entire furnace melter and refiner of a major float glass manufacturer, as well as to remove the existing glass level bowls from each side of the refiner. James M Uhlik* reports on the methods employed and the subsequent results of this work.

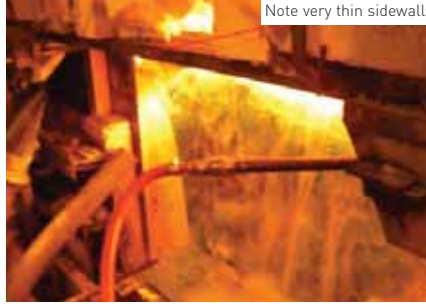
Note very thin sidewalls

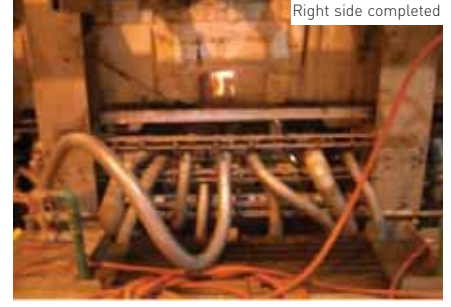
Right side completed

The binding steel, sidewall cooling nozzles and other refractory was then replaced as per the re-engineered design and work successfully completed.
